NASA Technical Memorandum 113128

Hot Corrosion of Single-Crystal NiAl-X Alloys

James A. Nesbitt
Lewis Research Center, Cleveland, Ohio

May 1998

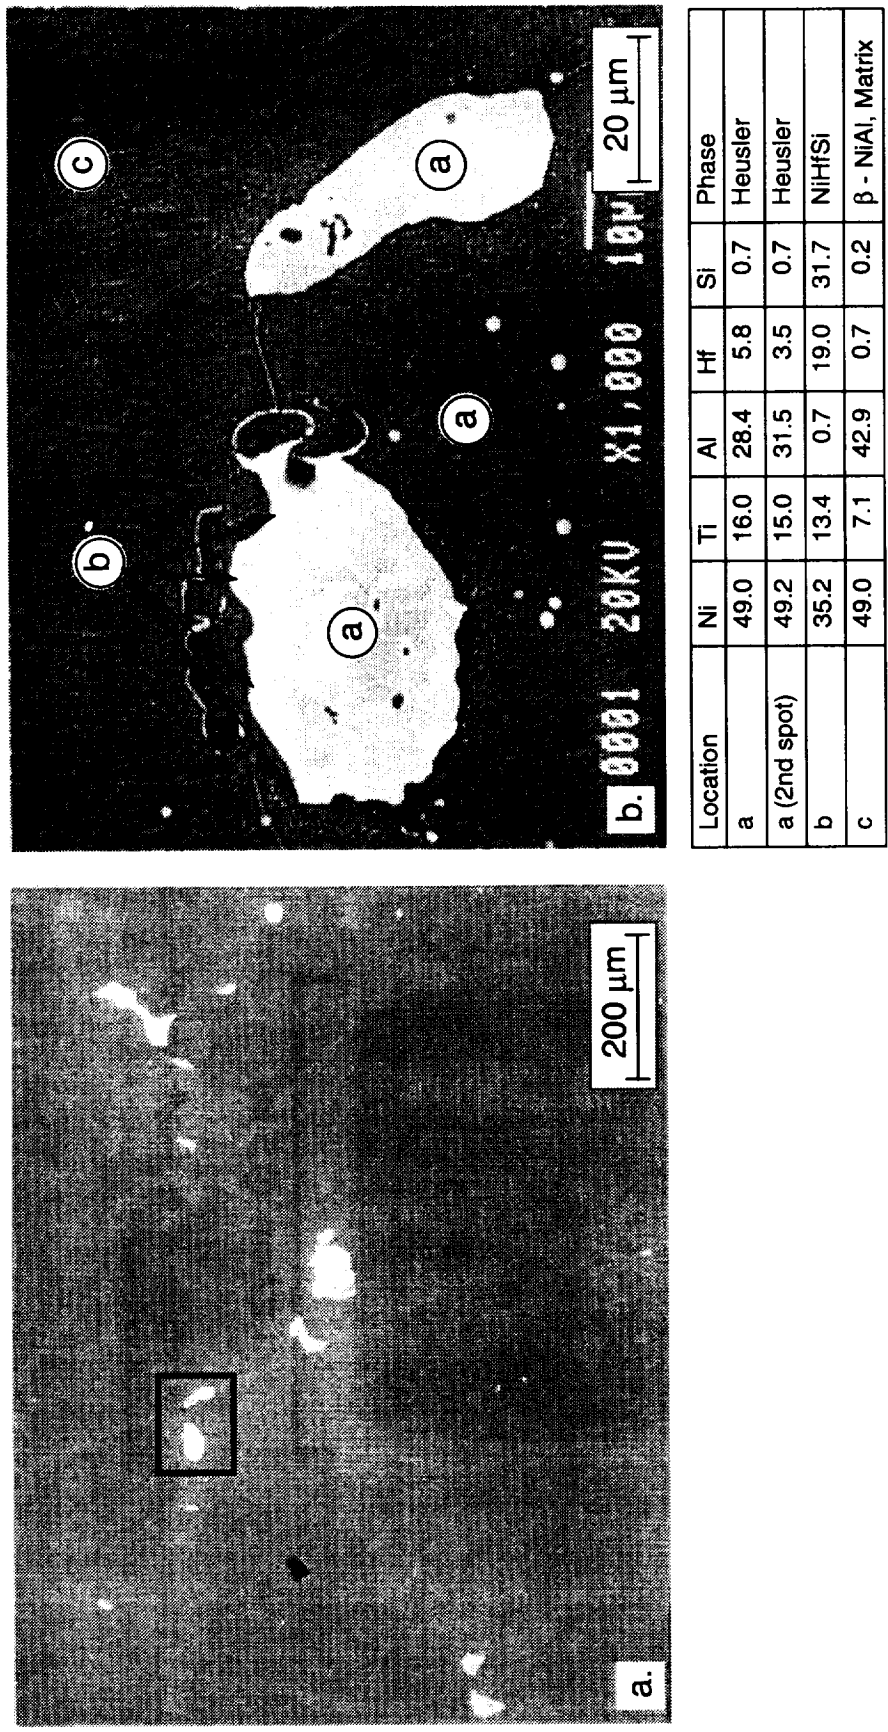
Fig. 1 Large multiphase precipitates found in all alloys except D218. Compositions in the table refer to labeled points a-c in the image.

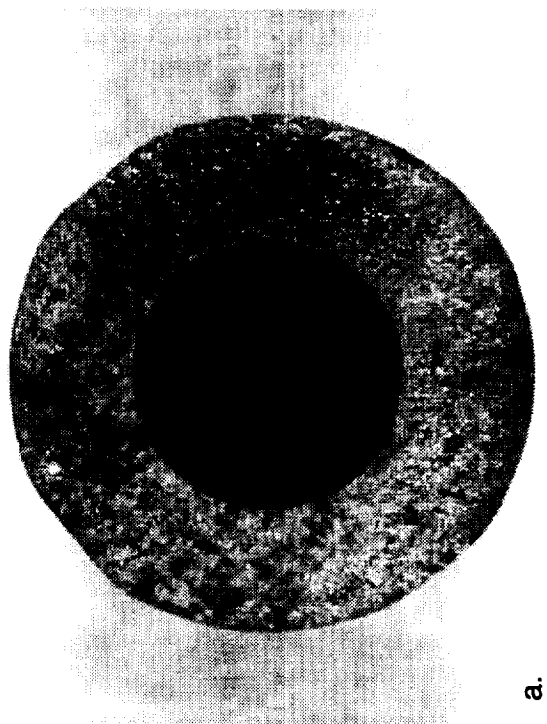
As previously mentioned, the two ends of the AFN24 sample were significantly different after electropolishing and chemical milling (Fig 10a,b). One surface appeared rough and shiny while the other exhibited the flat matte finish. Not surprisingly, the two ends responded very differently during hot corrosion testing with the originally rough but shiny end undergoing accelerated attack. Optical macrographs of the ends and curved surface are shown in Fig 50. Magnified SEM views of the rough end are shown in Fig 51. EDS spectra for the small bumpy nodules in Fig 51c are similar to those previously shown for scales with a similar morphology (see Figs 43 and 41b). The composition of the darker scale atop the mounds was also similar to that measured on the mounds in AFN19 (Figs 40c and 41c).

Fig. 10 Macrophotos of AFN24 after electropolishing and chemical milling, (a) shiny but rough, metallic surface (b), (c) dark, flat matte surface typical on high-Ti containing samples.

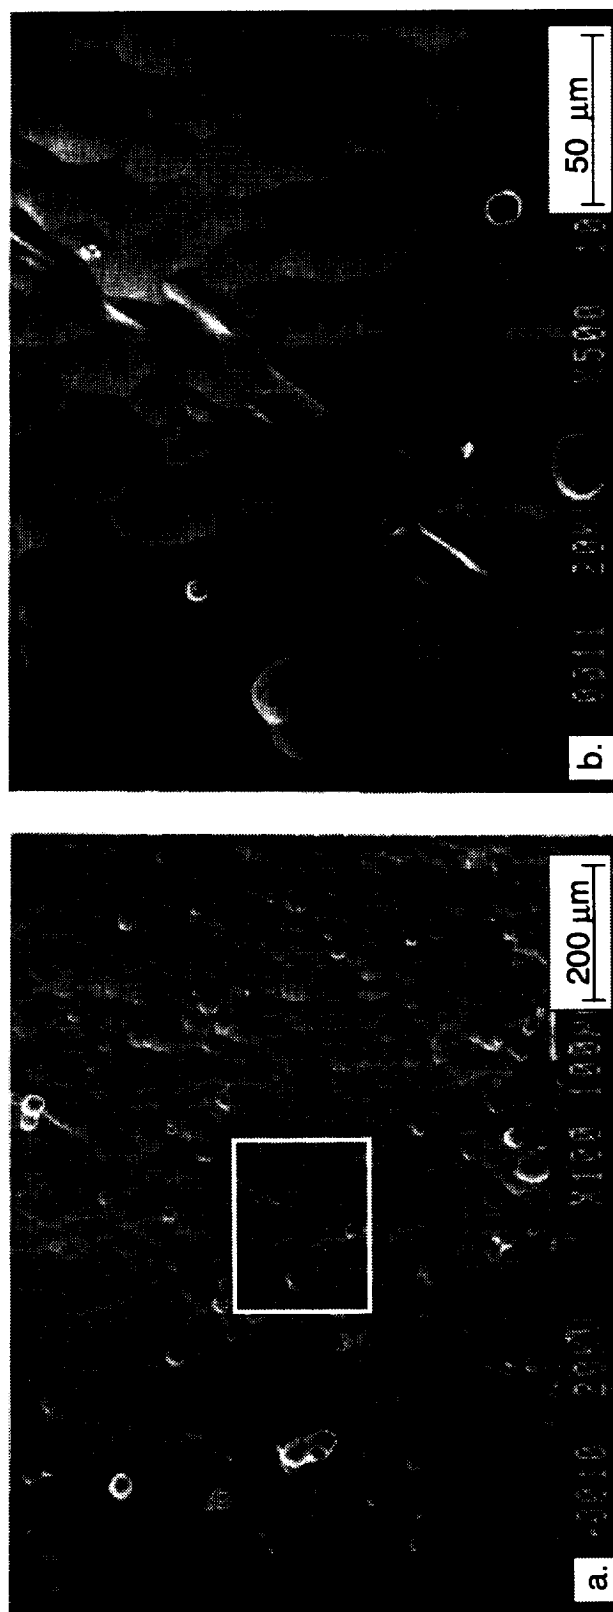
Fig. 14 SEM photos of the surface of D218 after chemical milling (a) general surface features, (b) high magnification of inset in (a) showing unidentified linear feature.

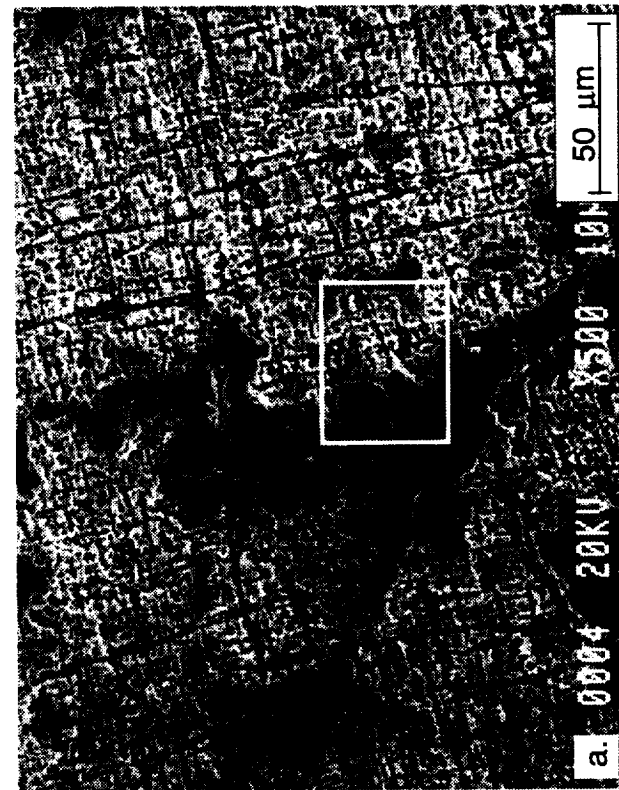
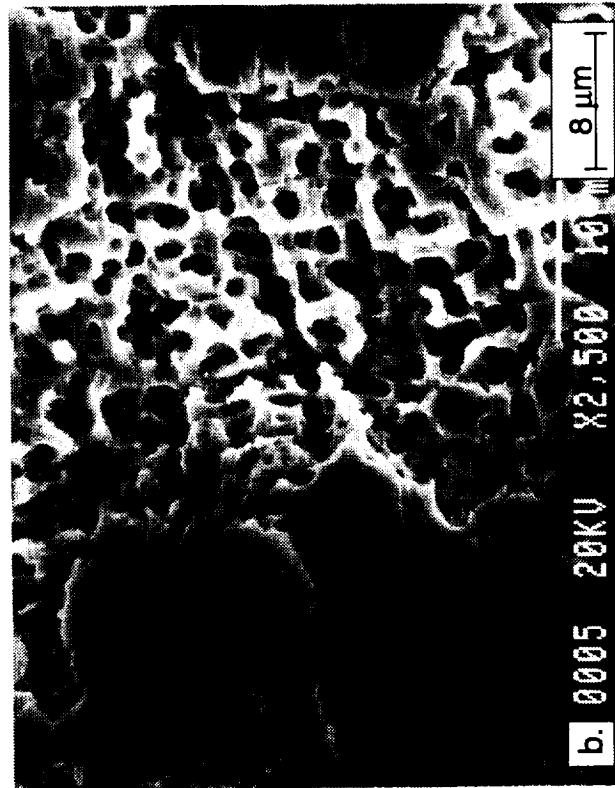
Fig. 24 SEM micrographs after electropolish and chemical milling of AFN26 showing dark regions not equally etched as surrounding material.

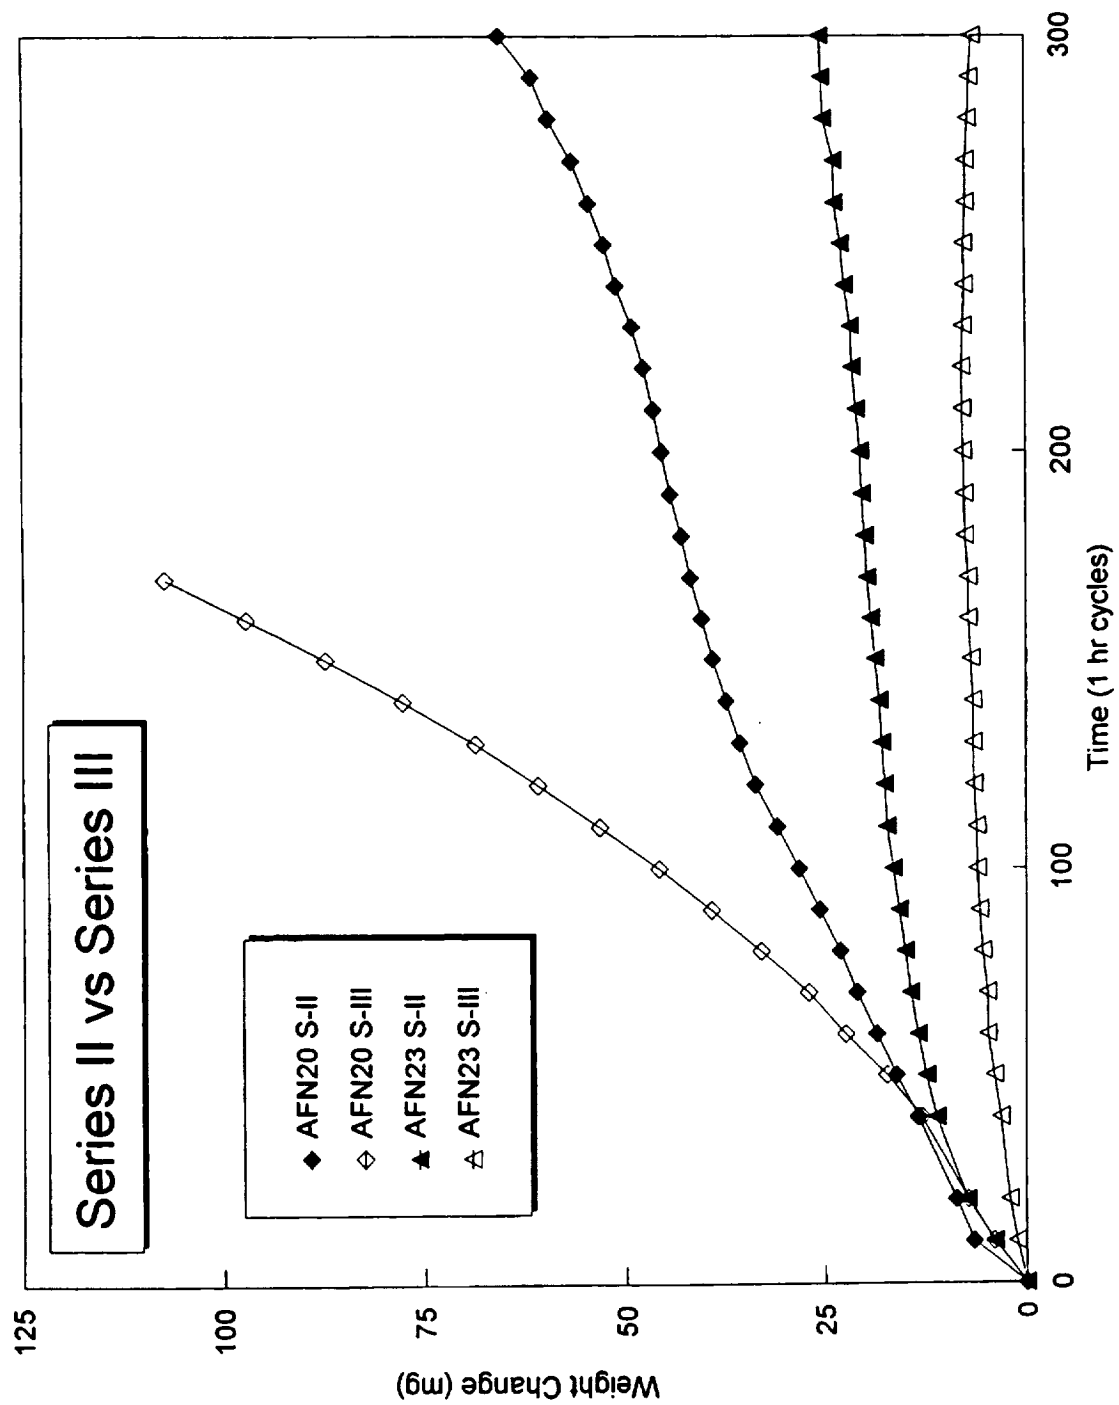
The weight change for most replicate samples during Series III were unexplainably greater than that for Series II (Figs 36,37). Only AFN23 showed a lower weight gain during Series III than that during Series II (Fig 36). However, the ranking of the alloys based on Ti and Cr content discussed above for Series II was consistent for Series III. Since three alloys and several replicate samples showed higher weight gains in Series III, it does not appear likely that the higher weight gains could be due to sample inhomogeneity although that appears to be the only reasonable explanation for the anomalous behavior of AFN23. Hence, the higher weight gains during Series III suggest a more severe test, although all measurable test parameters were identical. Consequently, comparisons between alloys will generally only be made within the same test series. Comparisons between test series will only be made to show that the increased weight gains can be directly correlated with the scale morphology. In these comparisons, the test series is clearly noted. It is noteworthy that if Series III was indeed a more severe test, D218, AFN23 and AFN26, which showed good resistance to hot corrosion attack, were not significantly affected.

Fig. 36 Weight change during burner rig testing for Series II versus Series III for AFN20 and AFN23 alloys.

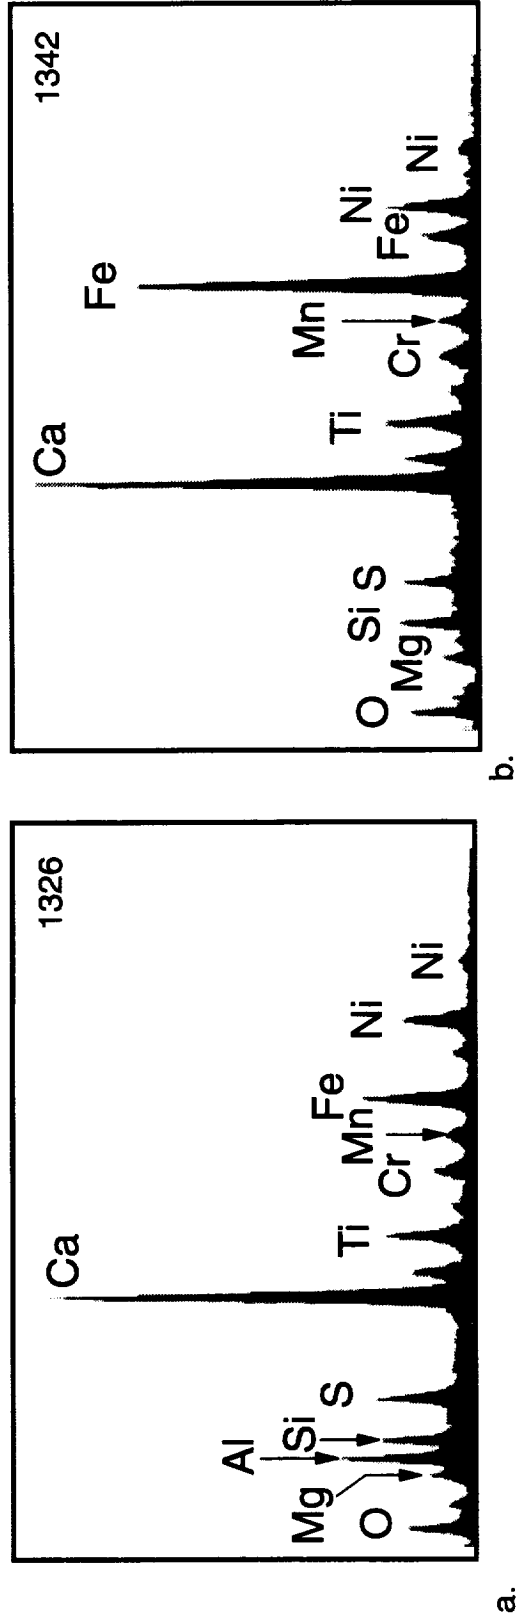
Fig. 46 EDS spectra of (a) the porous regions shown in Fig. 45a,b, and (b) the large particles in (d).

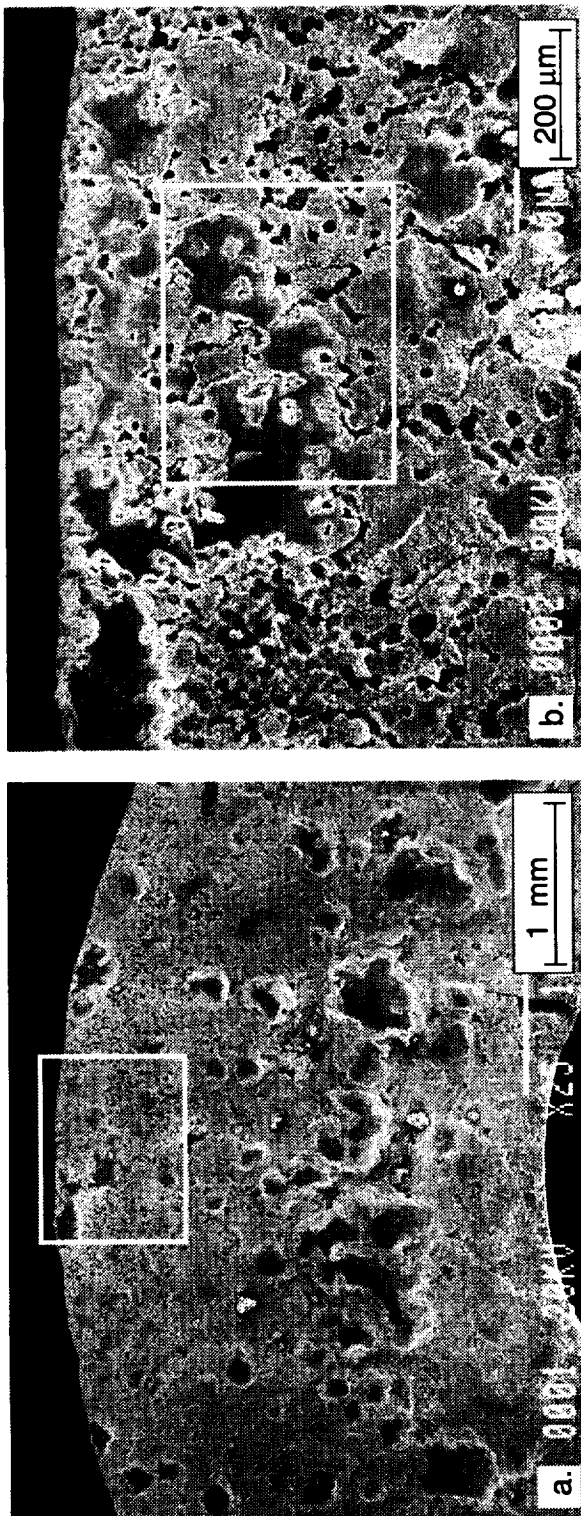
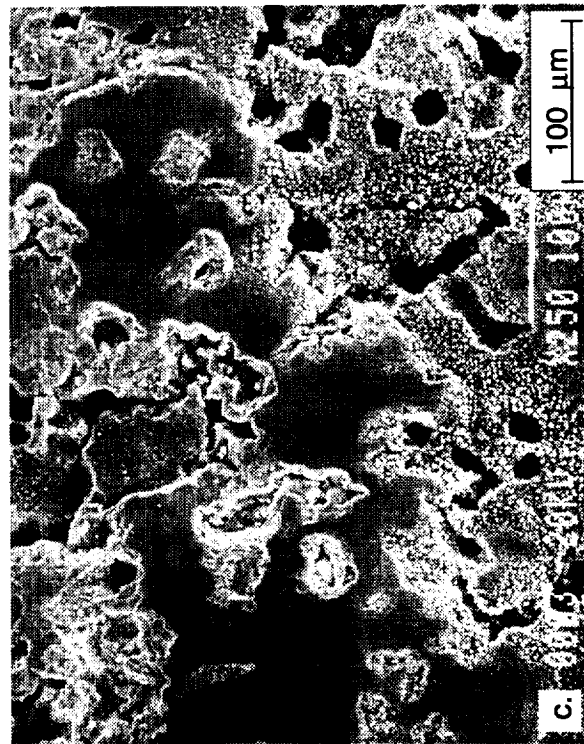
Fig. 51 SEM micrographs of the end of AFN24 after 300 cycles, (b) and (c) are magnified views of (a) and (b), respectively.

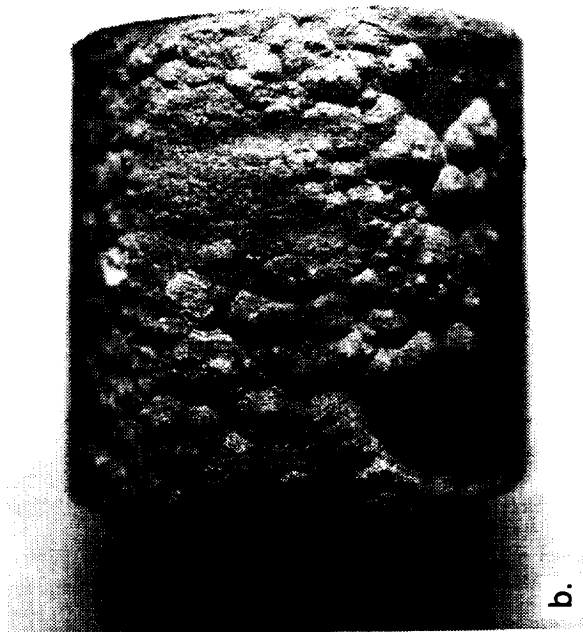
any indication of increased hot corrosion attack after 300 hrs (see arrow in Fig 53a). However, one of the other irregular surfaces on the curved surface of AFN25 which exhibited the typical flat matte finish after chemical milling, did undergo severe hot corrosion attack (Fig 53b). Hence, the different responses of a surface to the chemical milling treatment do not necessarily indicate the hot corrosion resistance. It again appears most likely that chemical inhomogeneities within the sample may be the cause for the widely different hot corrosion response on the same sample. Widely different responses to hot corrosion on the same sample was observed with numerous alloys (AFN20, Fig 59, Fig 82; D219A, Fig 68; AFN26, Fig 77d,e; to a lesser extent on D219B, Fig 69). Compositional inhomogeneities in AFN23 tested in Series II appears the only reasonable explanation for the anomalous behavior of this alloy which exhibited a higher weight gain in Series II than in Series III. The scale morphology of this alloy did show a localized accelerated attack on part of the curved surface during Series II testing.

Fig. 53 Macro photographs of AFN25 sample after 300 hrs. The arrow in (a) shows the same irregular region as in Fig. 52c and Fig. 11b.

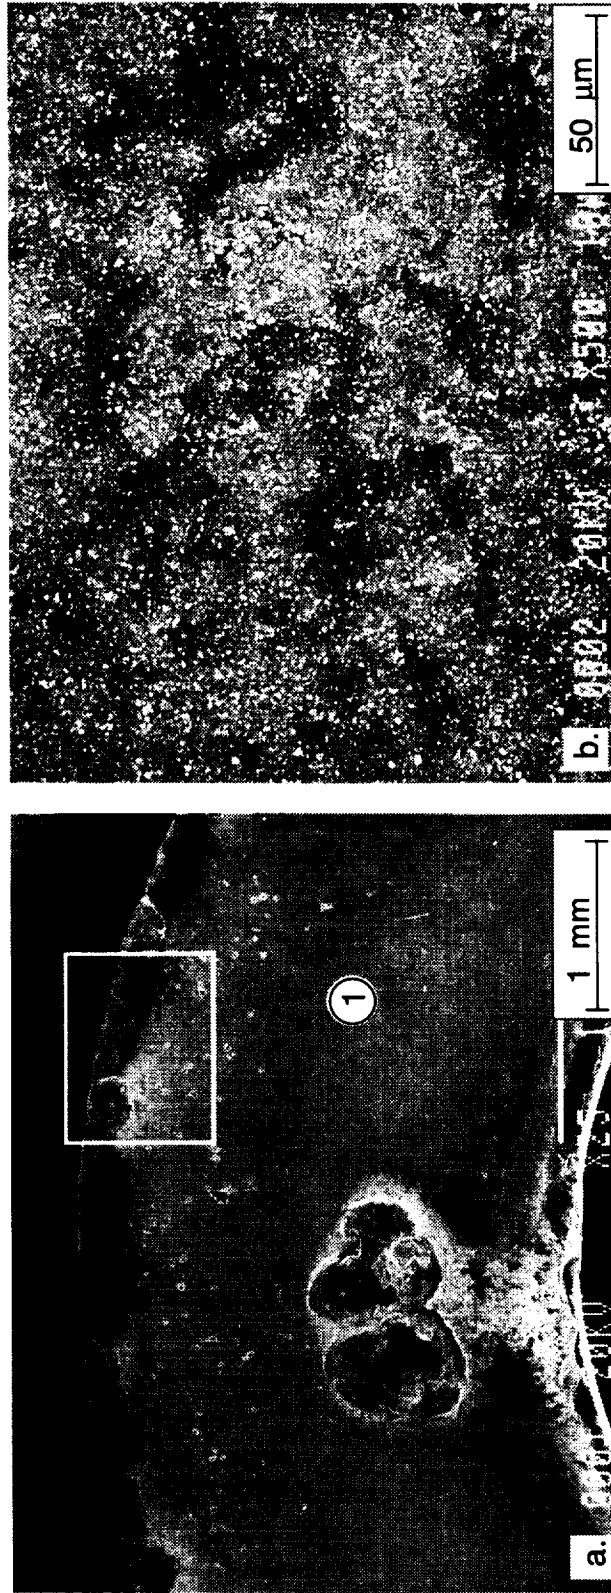
Fig. 55 SEM micrographs of the end of D218 shown in the box in Fig. 54a, (b) is a magnified view of the smooth scale near region indicated as (1). Box in (a) shows area of view shown in Fig. 56a.

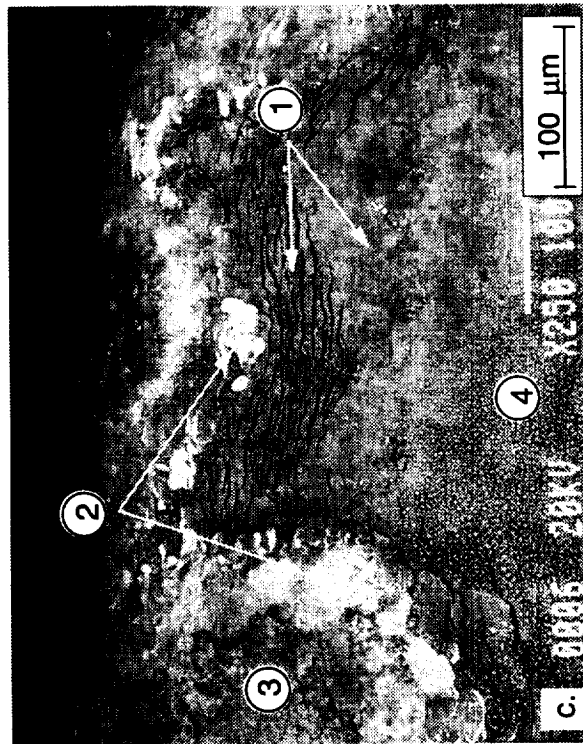
Fig. 56 SEM micrographs of the end of D218 shown in the box in Fig. 55a, (b) is a magnified view of (a) and (c) is a BSE image of (b).

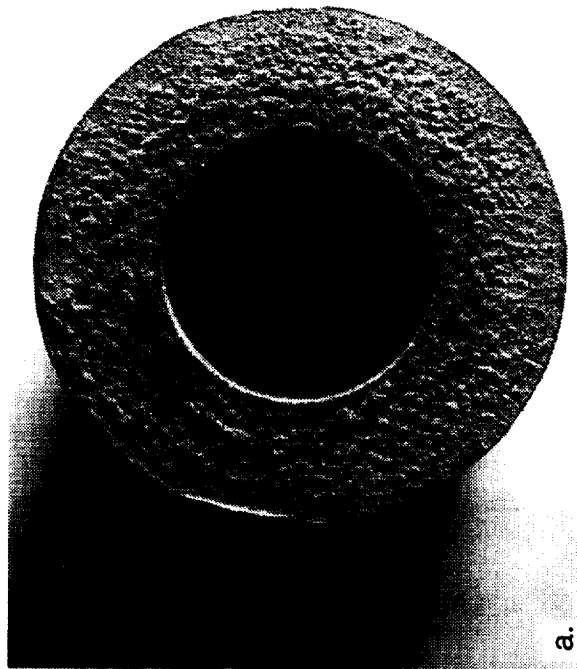
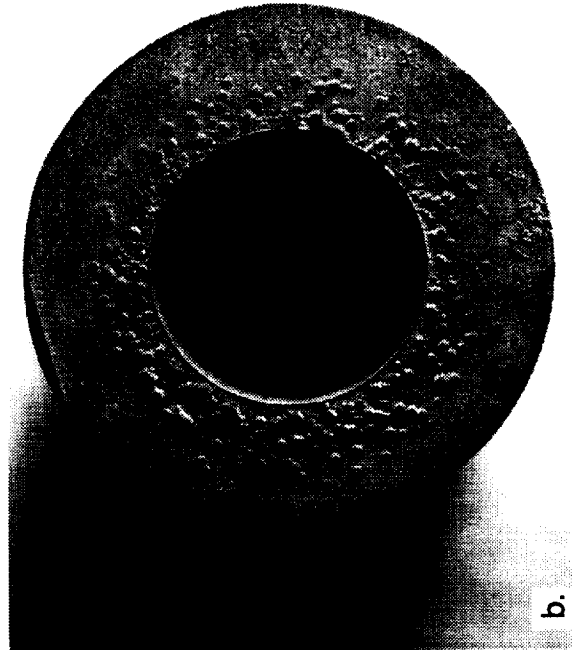
rougher than the other. Like AFN24, the corrosion morphology on each end was also different, apparent after only 50 hrs. The different corrosion morphology on the two ends after 100 hrs is shown in Fig 57. This morphology coarsened with time as shown after 200 and 300 hrs in Figs 58 and 59. It is interesting to note that although the mounds have grown slightly larger, there was no significant increase in the number of the mounds from 100 through 300 hrs. This behavior, that mounds which formed after short exposures only coarsened and coalesced with time without new mound formation, was typical on all the alloys. Nonuniform attack on the curved surface is shown after 200 hrs in Fig 58c,d. Although there is a noticeable increase in the size of the mounds and raised corrosion region after 300 hrs, again, there is no significant increase in the number of mounds or spread of the raised region on the curved surface between 200 and 300 hrs (compare Figs 58c,d and 59c,d). The somewhat parallel, raised lines in Fig 58c appear related to some dendritic structure. The lines are still visible after an additional 100 hrs (Fig 59c) indicating that, as stated earlier, the corrosion attack is by growth inward. Magnified views of the rough end of the sample (Fig 59a) are shown in Fig 60. The EDS spectra of the bumpy oxide in Fig 60c is Ca-rich, similar to that previously shown in Fig 46a. The smooth oxide in this figure is Al-rich with significant Ni and Ca similar to that in Fig 41c suggesting NiAl_2O_4 and/or mixtures with $\text{Ca}_3\text{Al}_2\text{O}_6$. The magnified view of the top of a corrosion mound in Fig 61a and the various contrasts in the BSE image of the same view given in (b) indicate the variety of oxides at the top and surrounding the mound. EDS analysis shows that the bright region (point 1) in Fig 61b is HF-rich, presumably HfO_2 . EDS analysis of the light gray oxide near the top of the figure (point 2) shows only the presence of Ni and O, indicating NiO. The EDS spectra of the area indicated as point 3 also indicates NiO, but with the presence of Mg and Ca. The EDS spectra of the darker oxide on top of the mound (point 4) is shown as Fig 61c and indicates a high level of Al but also substantial quantities of Ca, Ni and Ti. A lower magnification SEM view of the smoother end of the AFN20 sample (Fig 59b) is shown in Fig 62. The appearance of the scale morphology is similar to that previously observed on other alloys with much better hot corrosion behavior (Figs 49a, 52a). EDS analysis of the oxides and mounds were similar to that already described.

Fig. 57 Macrophotographs of AFN20 after 100 hrs showing different degree of attack on ends.

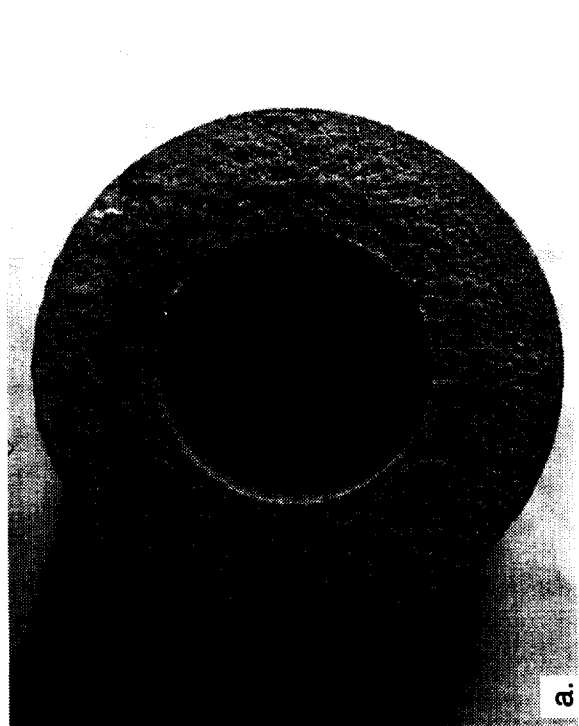
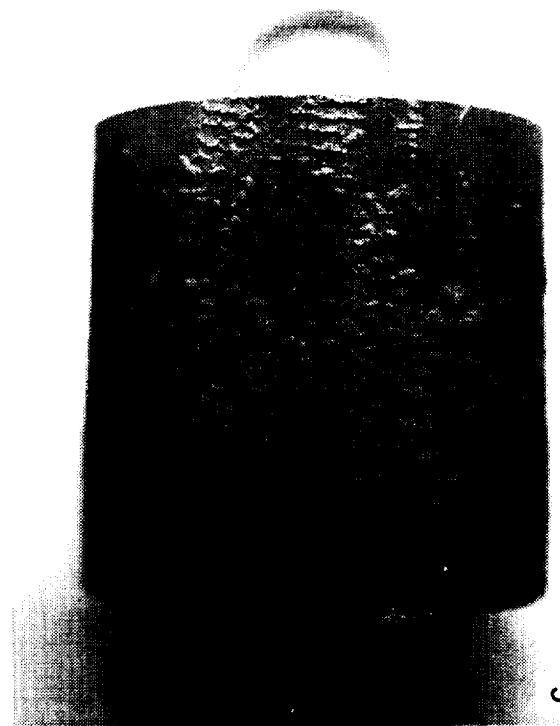
Fig. 58 Macrophotographs of AFN20 after 200 hrs showing coarsening of attack on ends (a,b) and accelerated attack on left half of curved surface (c,d).

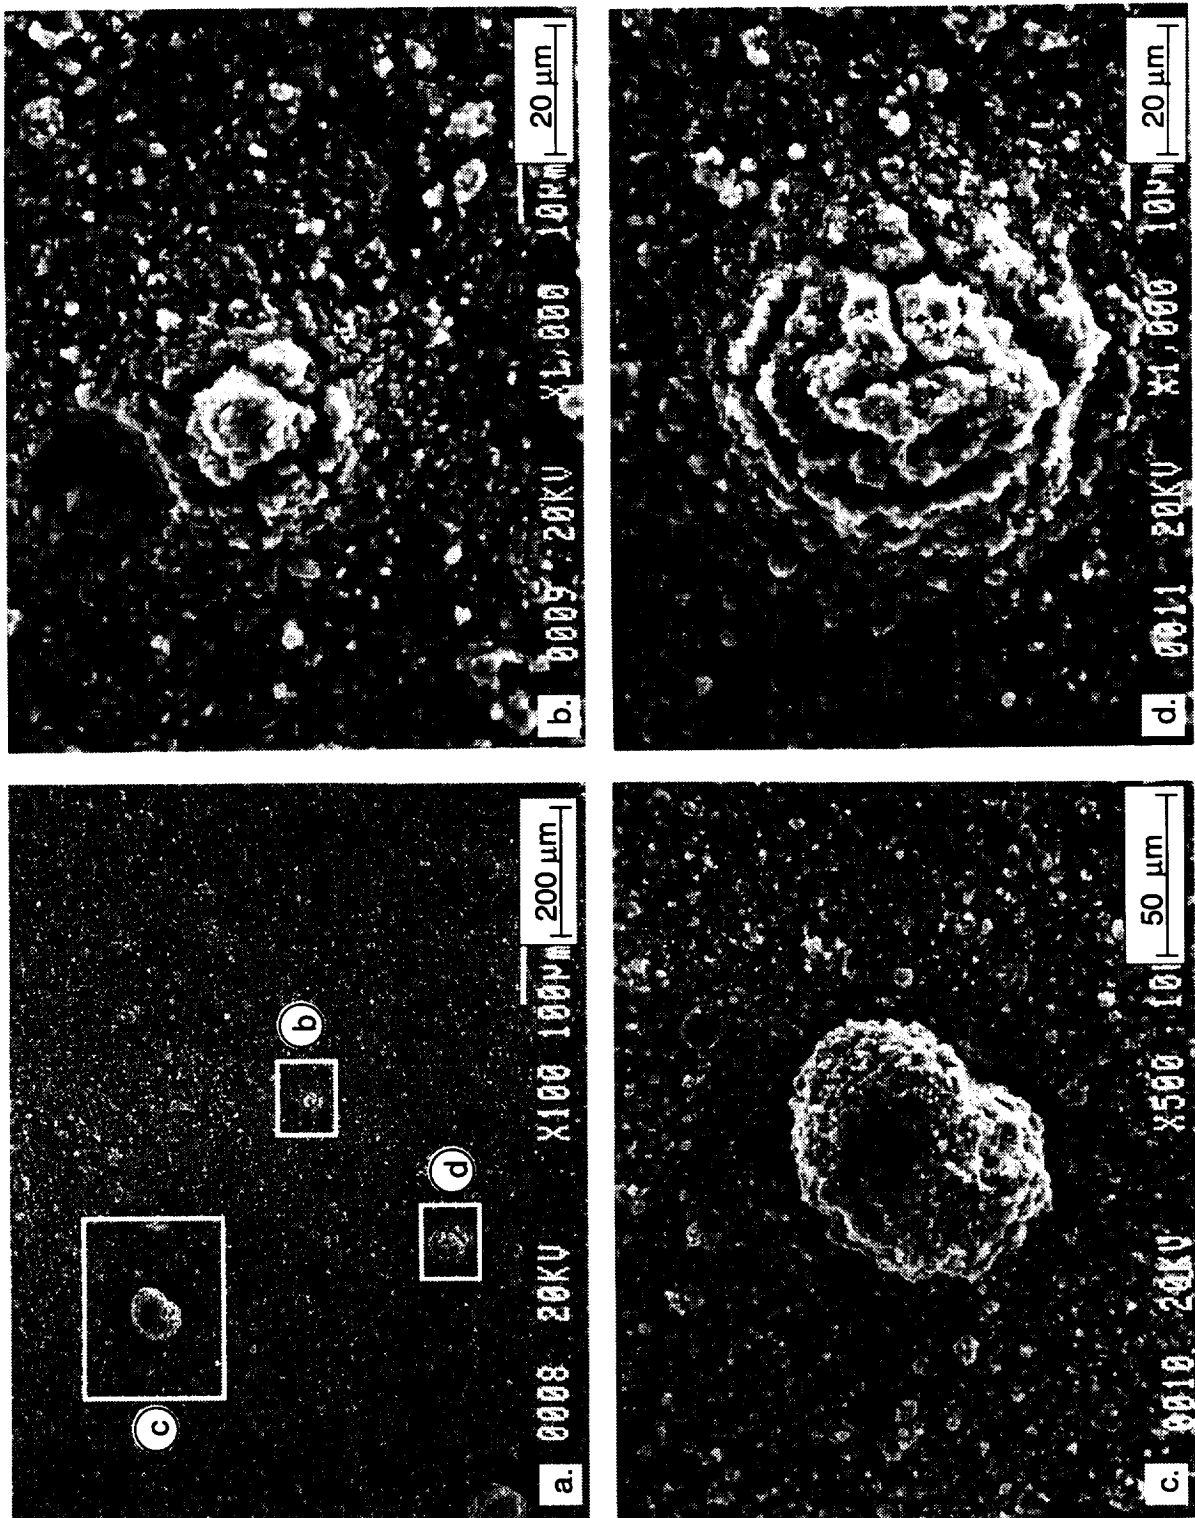
Fig. 66 SEM micrographs of the "smooth" curved surface of AFN20 after 300 cycles (right end of Fig59c,d), (b),(c) and (d) are magnified views of the boxed areas in (a).

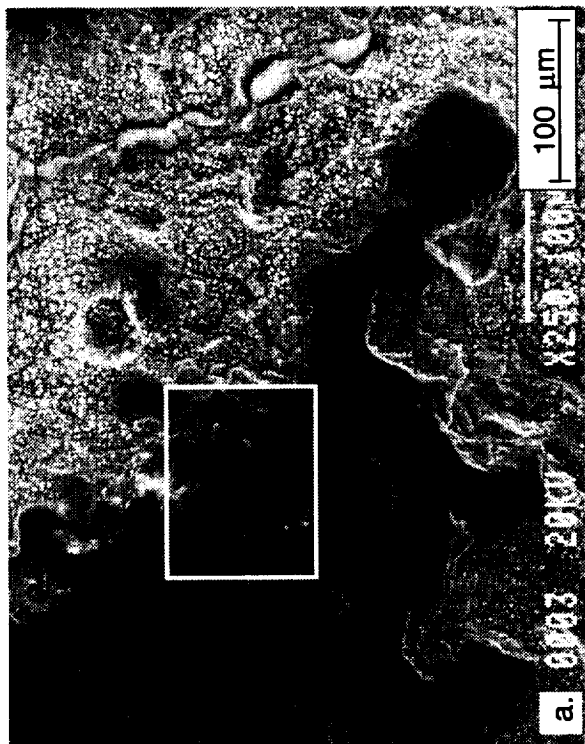
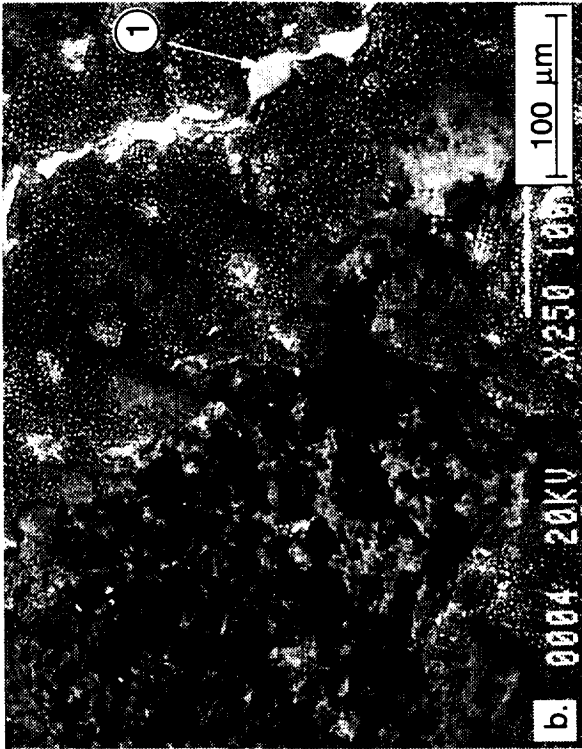
Fig. 70 SEM micrographs of the rough end of D219A after 300 cycles, (b) is a BSE image of (a) and (c) is a magnified BSE image of the box in (a).

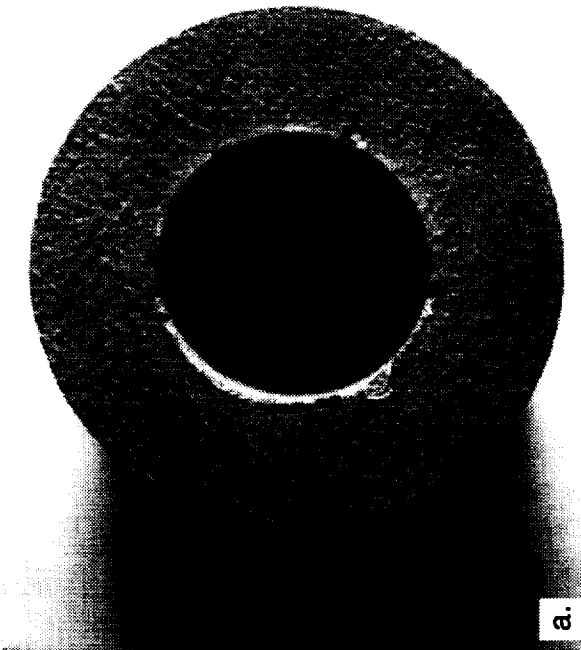
The uniform attack morphology was observed primarily on the two alloys with the poorest corrosion behavior, AFN20 and D219, but to a lesser extent on other alloys. The entire D219C sample showed this type of attack in Series III, as shown in Figs 75 and 76. However, D219D, also tested in Series III, only showed this uniform type of attack on the curved surface and on one end (Fig 74b,c). The other end showed the typical mound formation (Fig 74a). Other D219 and AFN20 samples tested in Series II also showed this form of attack on all (D219B, Fig 69) or some surfaces (AFN20, Fig 58a,d; D219A, Fig 68a). In addition, the morphology on portions of samples with better corrosion behavior also showed what appeared to be this type of attack (AFN23, Fig 49a and region 2 in Fig 49b; AFN26, Fig 82d-f). It is clear that some samples showed both distinct mound formation as well as the uniform attack (Figs 59a,b, 68a,b, 74a,b, 82a,d). As previously stated, mechanically polishing the surface of D219 resulted in a change from the uniform attack morphology to only mound formation (Figs 71-73). However, as indicated above, it

Fig. 75 Macrophotographs of D219C after 50 hrs of testing (Series III). Sample surface had been chemically milled.

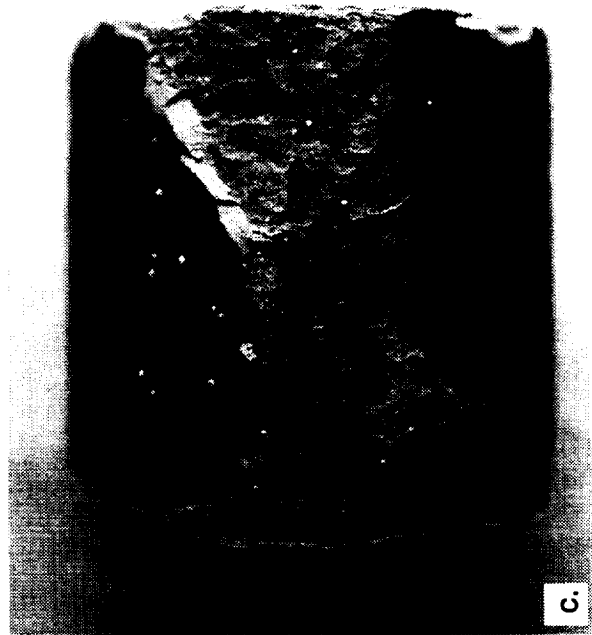
There were significant differences in the hot corrosion response between samples which were chemically milled and those mechanically polished through 600 grit SiC paper. The lower weight gain of the mechanically polished samples (Fig 38) is reflected in the corrosion morphology after 50 hrs, as shown in Figs 71 and 72. Small distinct mounds are apparent on the surface and ends although one of the samples (D219F) exhibited a localized, scaly reaction product on one portion of the curved surface (Fig 71c). The growth of the corrosion mounds after 300 hrs on D219E is shown in Fig 73. In contrast to the mechanically polished samples, most of the surface of the chemical milled samples showed a relatively uniform and continuous attack (Figs 74, 75) although one end of D219D exhibited the distinct mound formation (Fig 74a). The uniform attack on the curved surface of the chemically milled samples shows the cast dendritic structure in relief (Fig 75c), again indicating that the growth of the hot corrosion attack is inward. Although the uniform attack gives an appearance as being less severe than the large, distinct mound formation, the depth of the attack was sufficient that after only 100 hrs, large, relatively thick corroded layers began to spall from the curved surface (Fig 76). Some of the cast dendritic structure is still apparent in the intact surface (Fig 76d).

Fig. 76 Macro photographs of D219C after 200 hrs (Series III). Sample surface was chemically milled.

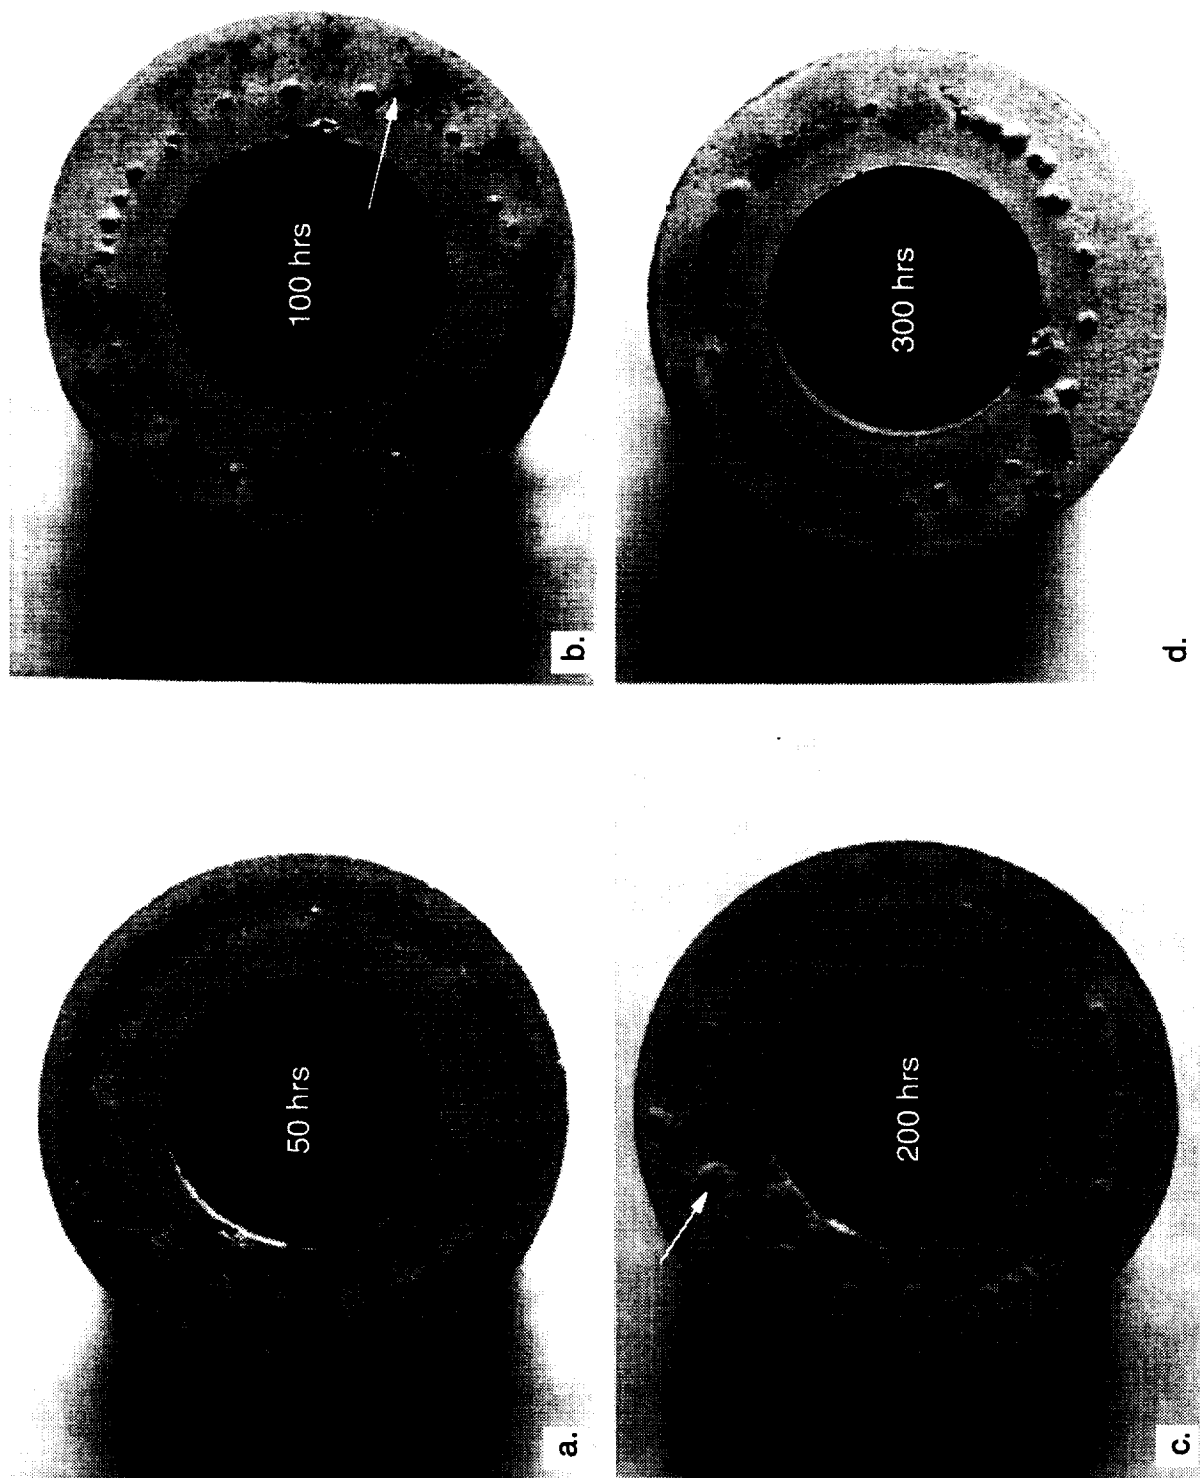
The corrosion mounds appeared at short times and grew with additional testing although few new mounds were initiated after 50-100 hrs. Most of the mounds on the end of D218B can be discerned after only 50 hrs, as shown in Fig 79. A single mound growing at a crack is apparent at 200 hrs but not at 100 (see arrow in Fig 79b,c). Most mounds are not apparent after 50 hrs in D218D which had been mechanically polished (Fig 80). However, all of the mounds visible after 300 hrs are visible after 100 hrs. These observations for D218B and D218D suggest that the surface finish may be affecting the initiation of the corrosion mounds. In D219, with a poorer corrosion behavior than that of D218, the mounds are clearly apparent after 50 hrs and grow through 300 hrs, however without any observable increase in the number of mounds (Fig 81). Both the growth of distinct mounds and the more uniform attack is evident for AFN20 in Fig 82. Even after 150 hrs, the uniform attack (Fig 82d-e) has grown but has not spread to the edges of the sample. Hence, it appears that the corrosion attack on most samples is initiated at very distinct locations and at short times with little additional attack initiated with further testing.

Fig. 79 Macrophotographs of the ends of D218B after (a) 50, (b) 100, (c) 200, and (d) 300 hrs (Series III). Sample surface was chemically milled.

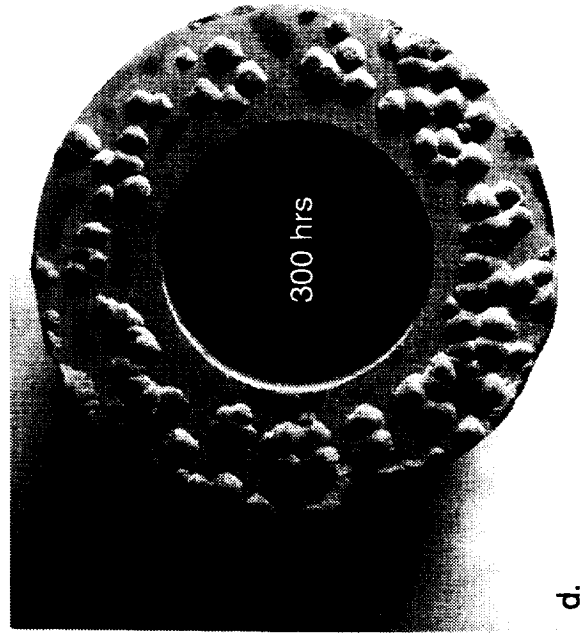
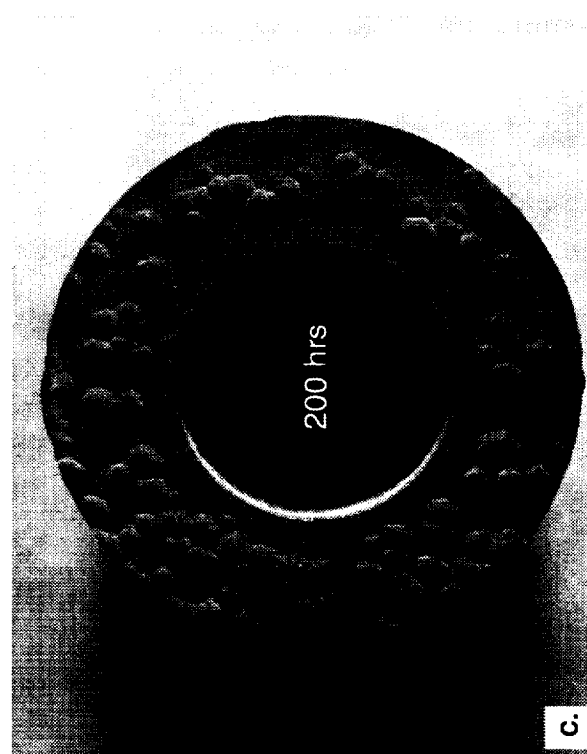
Fig. 81 Macro photographs of D219E after 50, 100, 200 and 300 hrs (Series III). Sample surface was polished through 600 SiC paper.

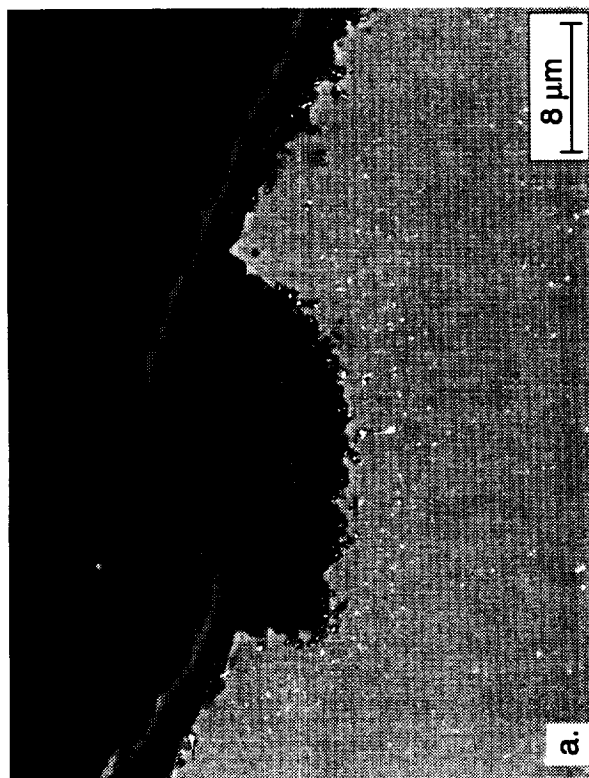
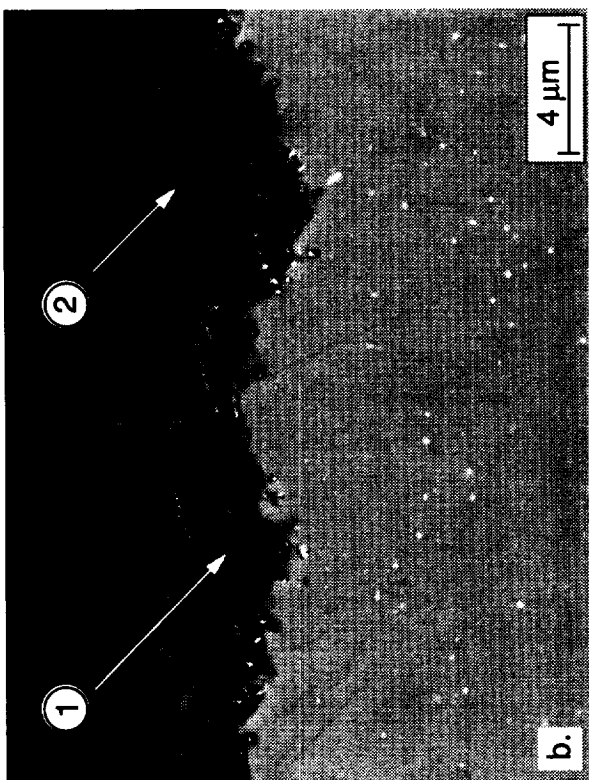
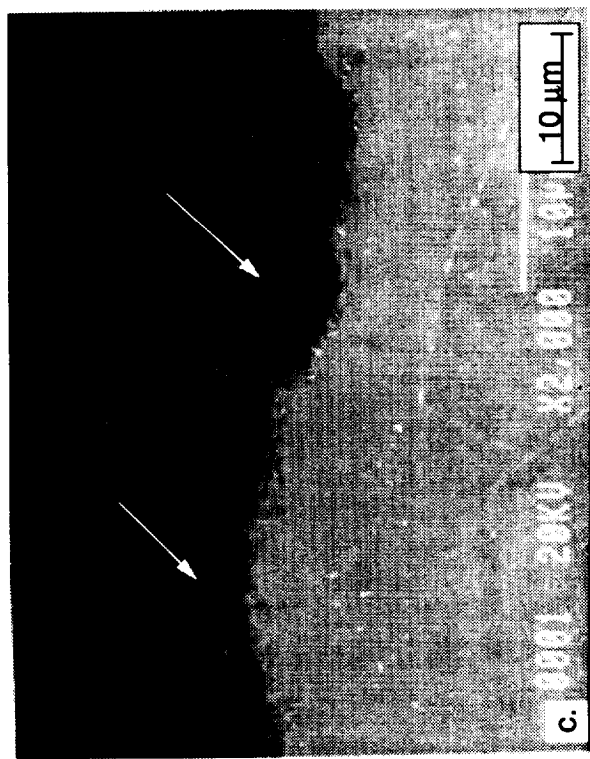
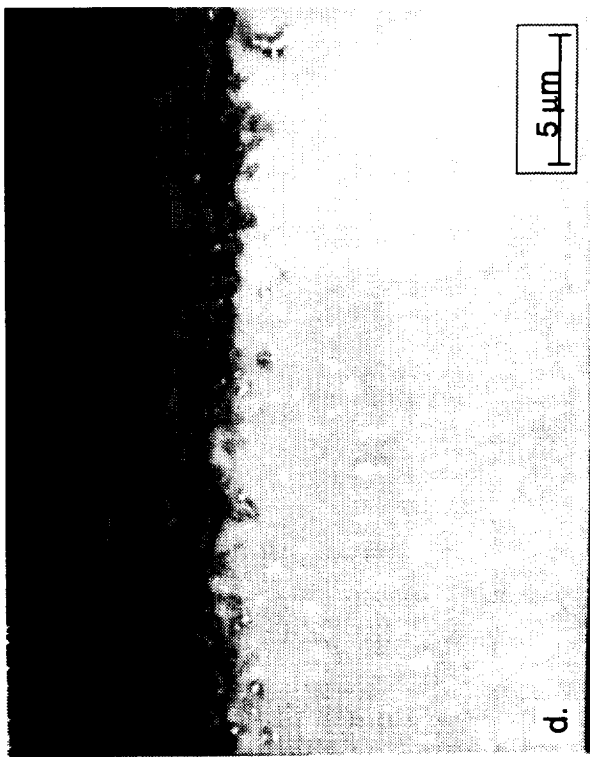
Fig. 91 Possible initiation sites in (a) AFN19, (b) D219 and (c,d) AFN20.
